**BISSETT CREEK WASTE DISPOSAL SITE
CORPORATION OF THE UNITED
TOWNSHIPS OF HEAD, CLARA AND MARIA**

2010/2011 BIENNIAL REPORT

Jp2g Consultants Inc.
Engineers • Planners • Project Managers
Project No. 2006023M – AOR
and
AECOM
File No. 60246826-6.1

May 2012

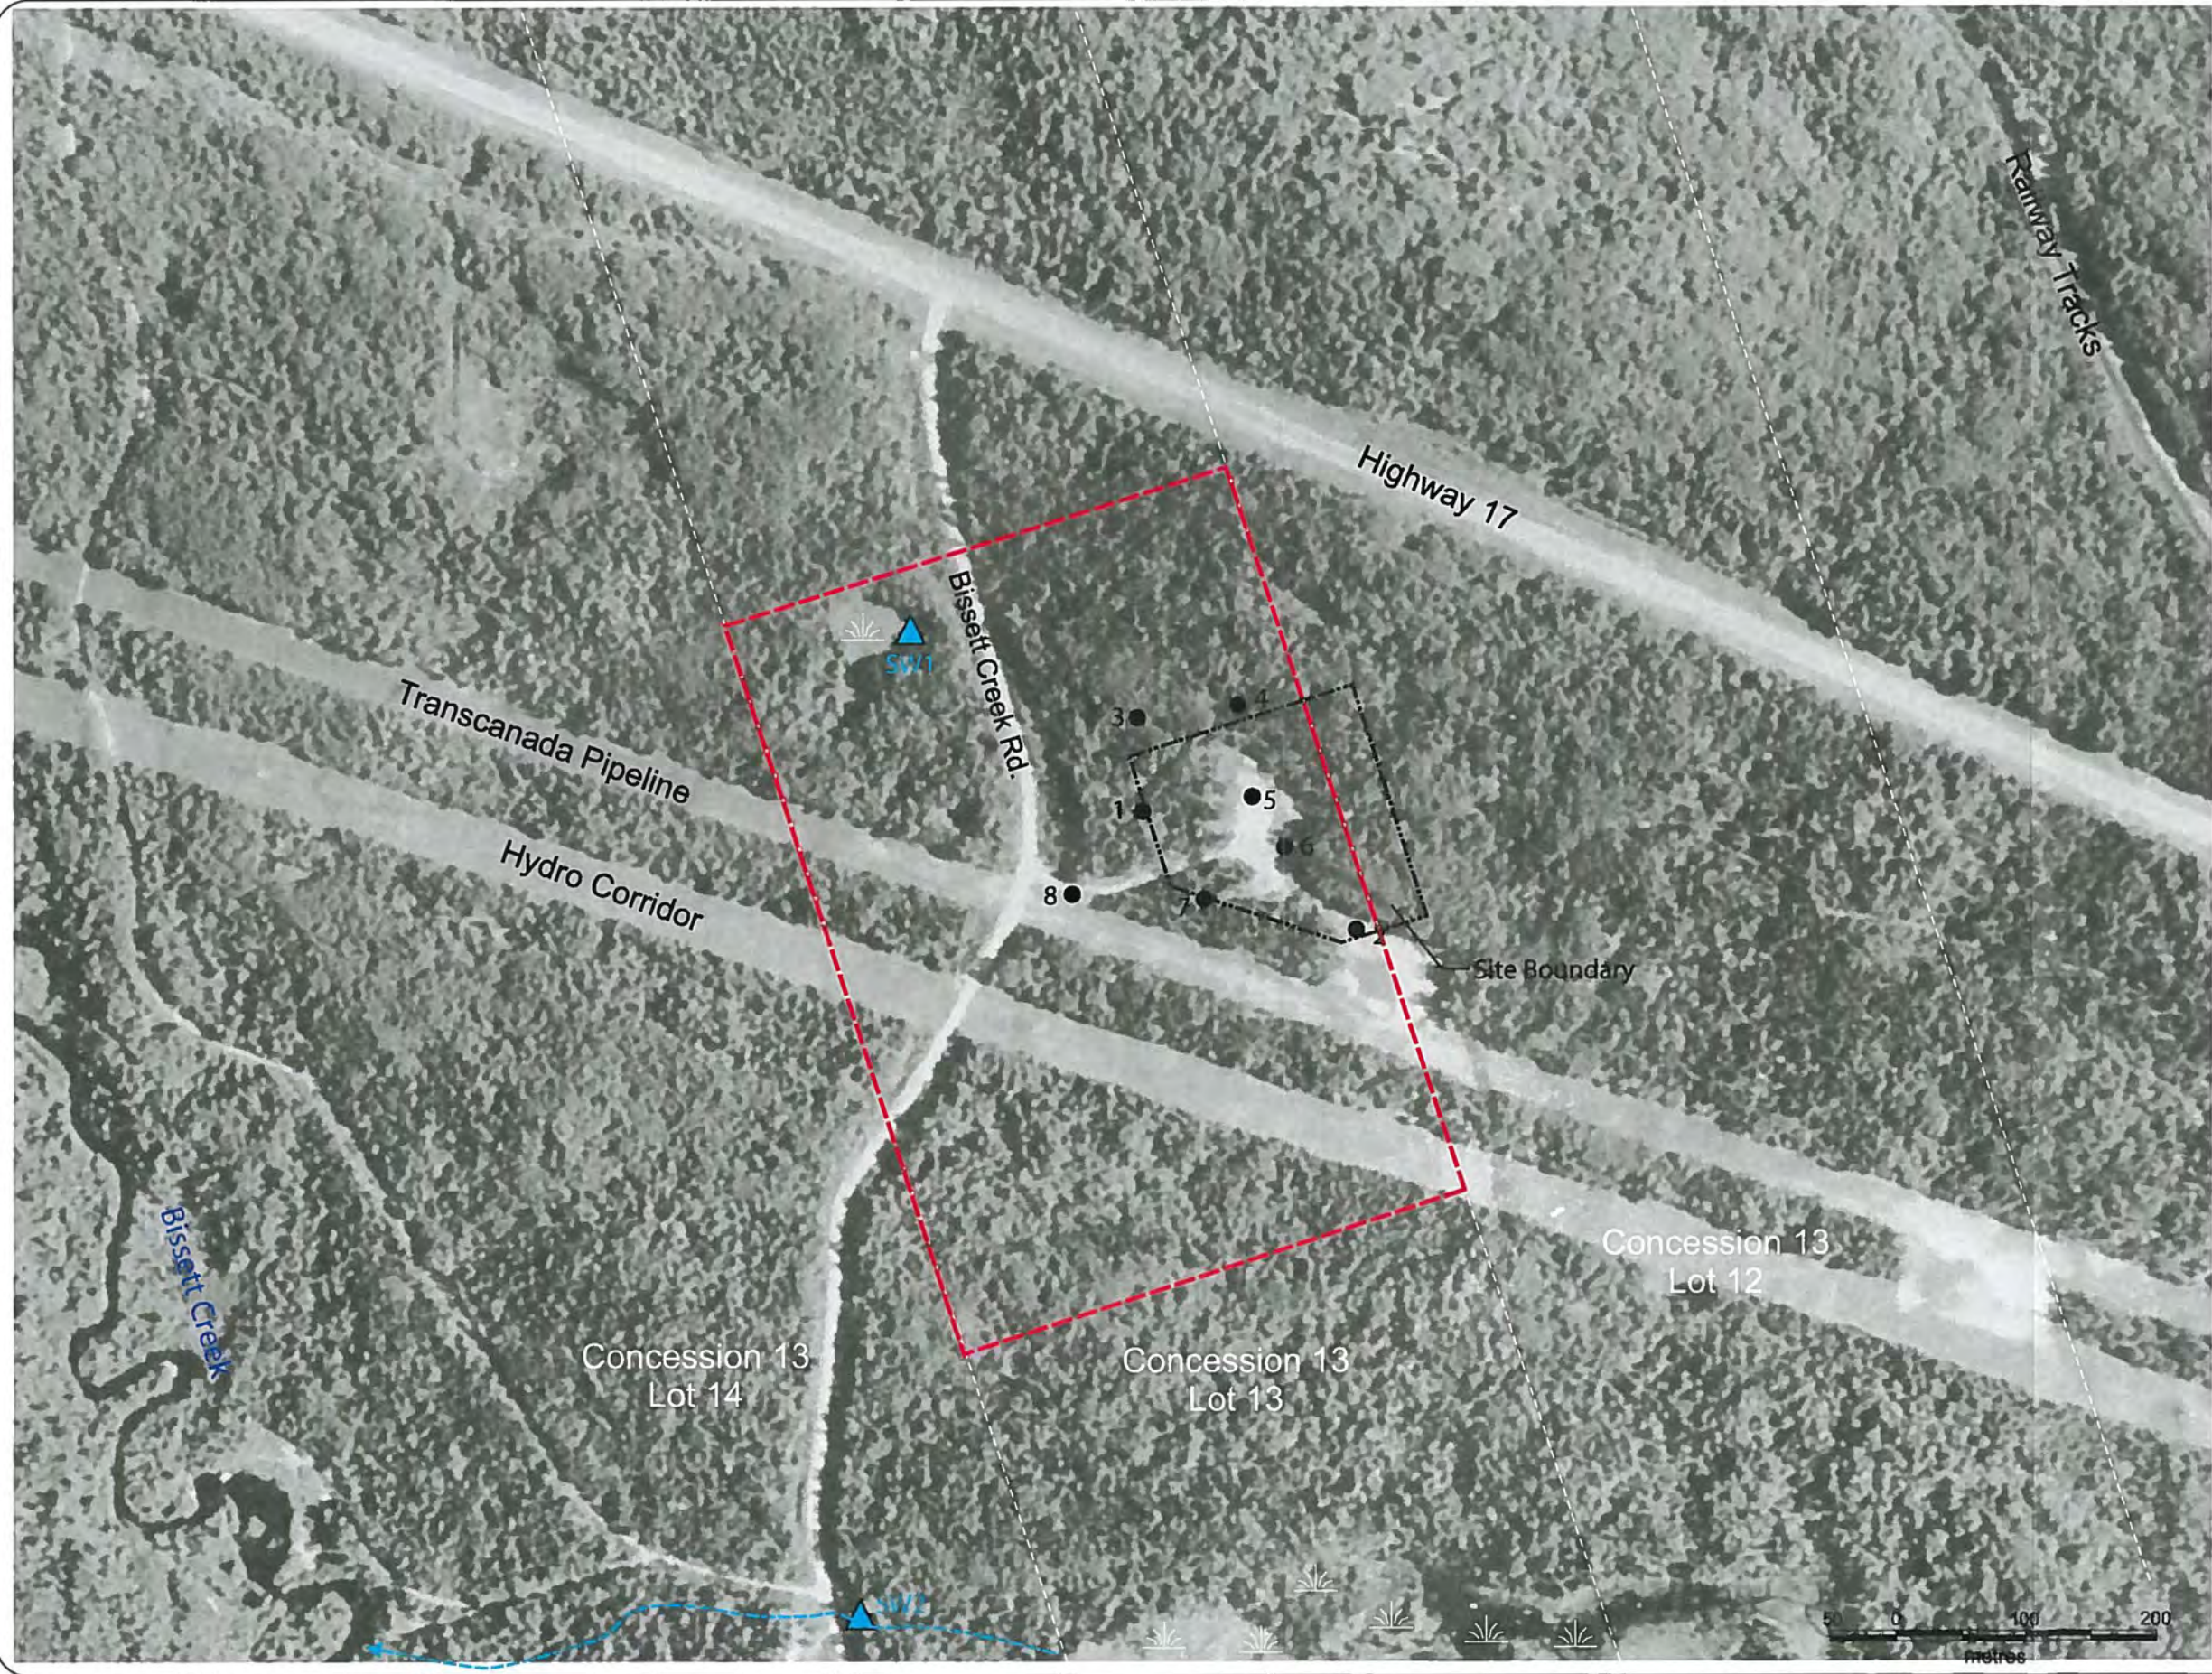
- Borehole Location and Designation
- ▲ Surface Water Sampling Locations
- - - Containment Attenuation Zone (CAZ) for the Site

The two downgradient surface water stations with staff gauge installations were monitored in April 2010 and June 2011 (Figure 1). SW1 is located in a wetland depression northwest of the site. Good wetland vegetative growth was observed during the visits in 2010 and 2011 at SW1 with no staining or stress apparent, indicating no obvious leachate influences. SW2 is located in an intermittent tributary of Blissett Creek, southwest of the site. Good vegetative growth was observed during the visits in 2010 and 2011 with no signs of stress on the vegetation located in and around the tributary, indicating no obvious leachate influences.

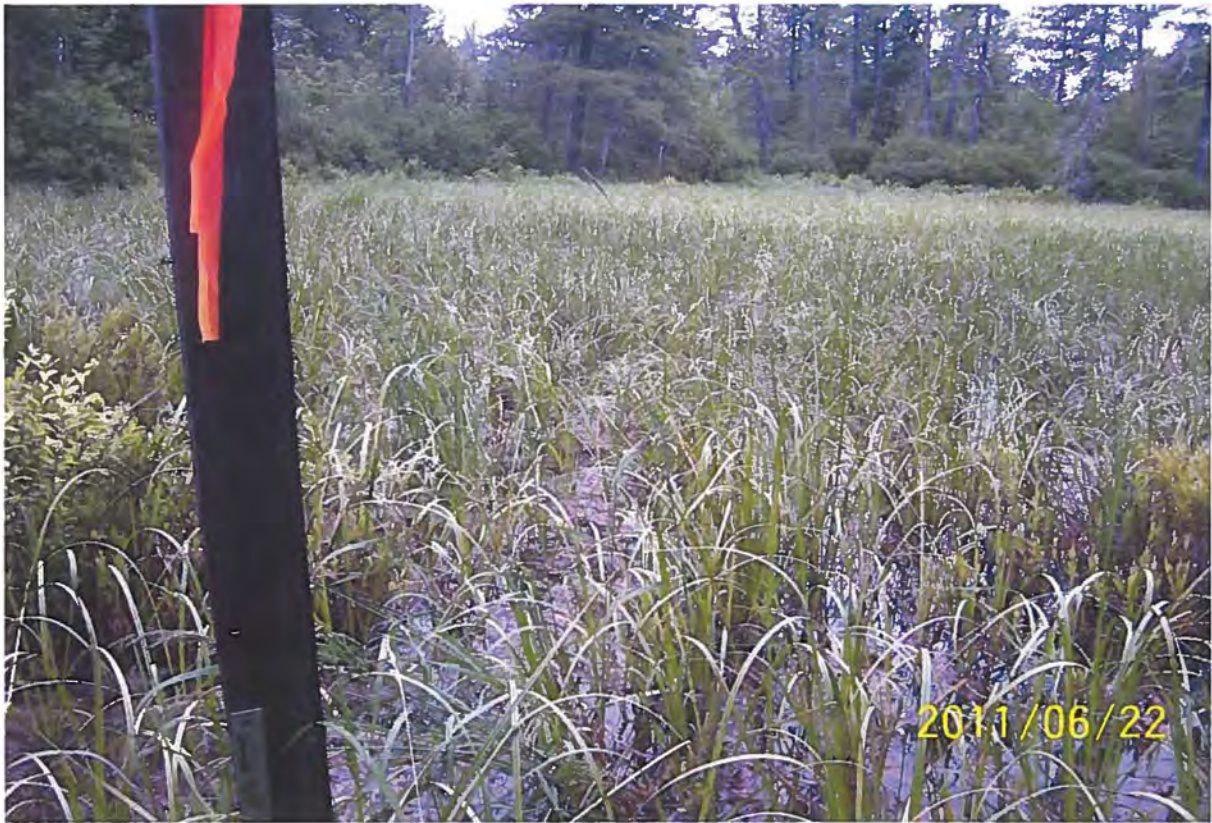
SW 1 Area

At SW1, COD and iron levels were elevated compared to the background overburden values. The elevated COD and iron levels are likely due to natural conditions since SW1 is located in a stagnant wetland. All other landfill indicator parameters are lower or within the range of background overburden concentrations, thus indicating no leachate influence.

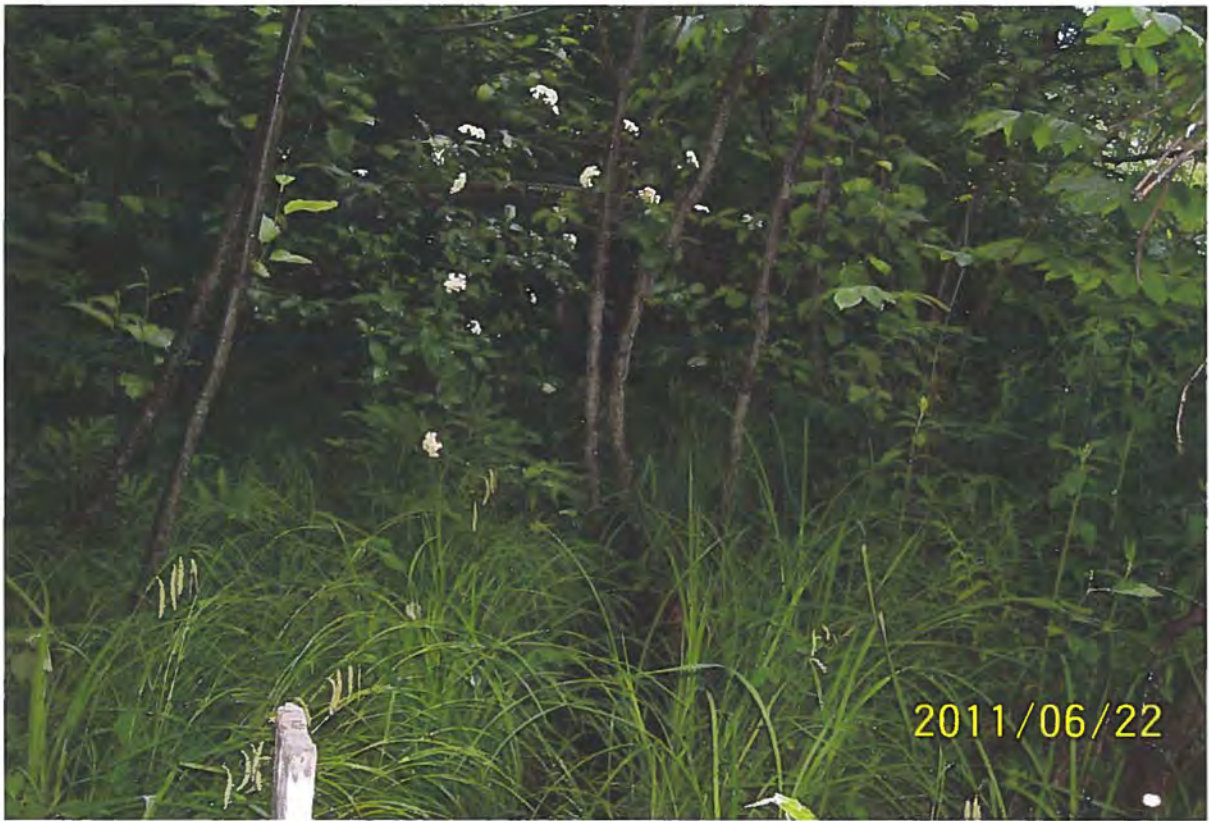
SW 2 Area

At SW2, iron and COD (2011 only) levels were elevated compared to the background overburden values. The elevated COD levels are likely due to natural conditions since SW2 is located downstream from a wetland. The iron concentrations at SW2 exceeded the PWQO. Elevated iron concentrations do not appear to be related to the landfill, as iron concentrations are frequently elevated in Precambrian bedrock settings and the concentrations at SW2 are much higher than in the leachate. There are no other exceedances of the PWQO at either surface water sampling location.
